JAMIE WHITTEN LOCK CLOSURE 2020

MOBILE DISTRICT: JOHN C. STENNIS SPILLWAY GATE DAMAGE

OLIVER & BANKHEAD LOCK - 30 DAY CLOSURES

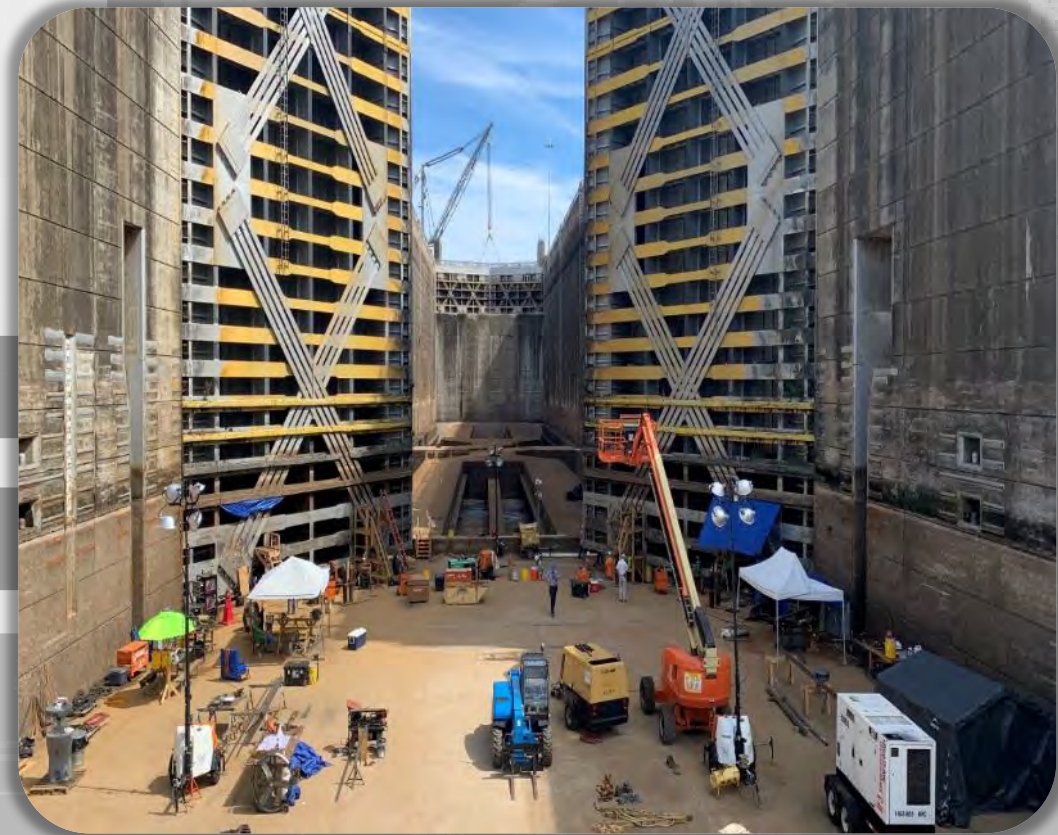
MAJOR DESIGN FLAW DISCOVERED THROUGH FEA

- 8 LOCATIONS ON DOWNSTREAM MITER GATES
- **APPROXIMATELY 6' x 7' HALF INCH WELDING REMOVED**
- REPLACED WITH SHOP-MILLED THICKER PLATES WITH TRANSITIONS
- **ADDITIONAL LONGITUDINAL AND TRANSVERSE STIFFENERS ADDED**
- SUBSTANTIAL WELDING
- **48 STRAIN GUAGES STRATEGICALLY LOCATED TO MONITOR POTENTIAL CHANGE IN STRESS**

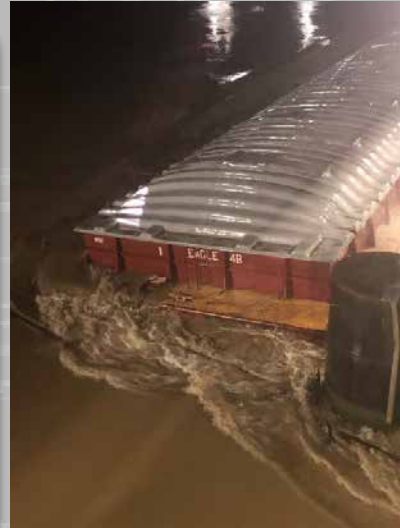
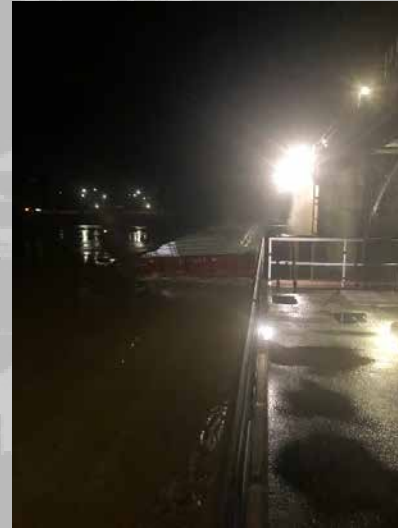
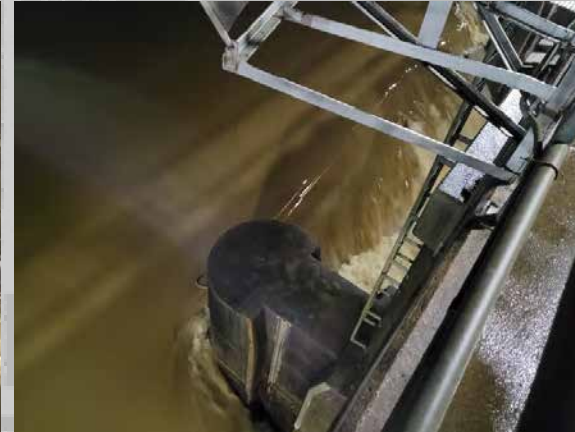
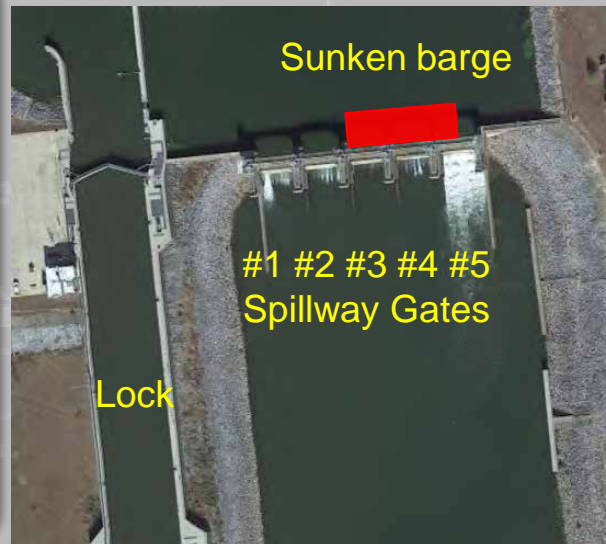
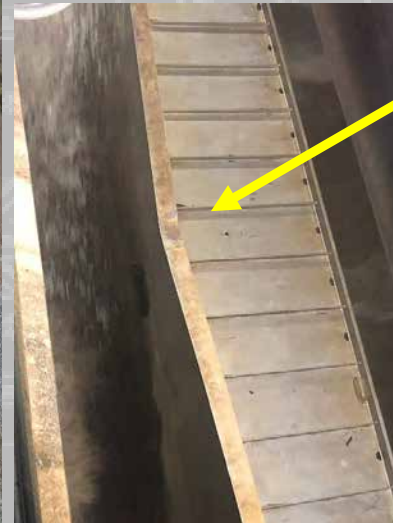
- 09 JUNE 2021
- Damages evident over 80% of width and 65% of height
- Significant damage to upstream apron
- Scour holes downstream of stilling basin
- HSS inspection determined gate not fit for service & replacement is required.

Barge sunk on the spillway

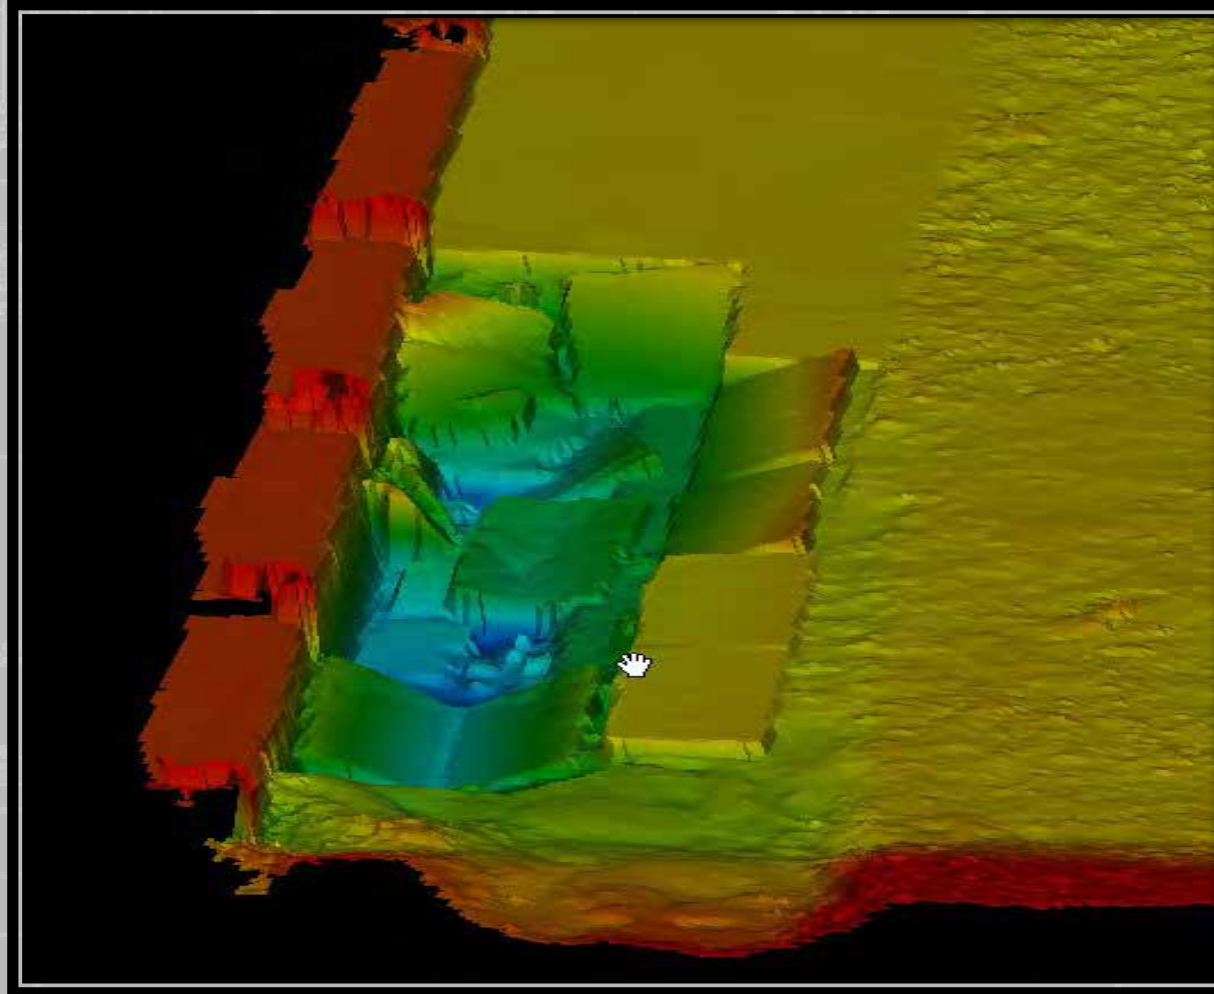
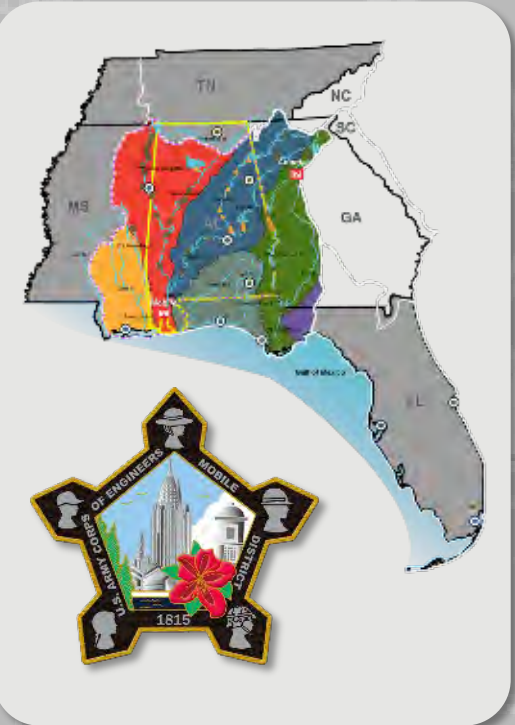
UPSTREAM APRON DAMAGE

- Approximately 150' X 60' concrete apron damaged
- Scour varies with deepest location ~20'
- At deepest location, within 5' of undermining structure
- Approximately 3,000 tons of rock displaced downstream of stilling basin

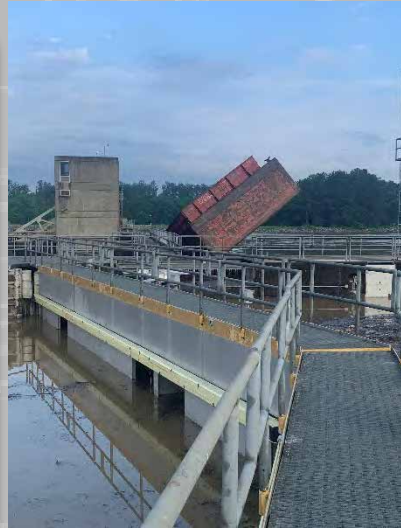
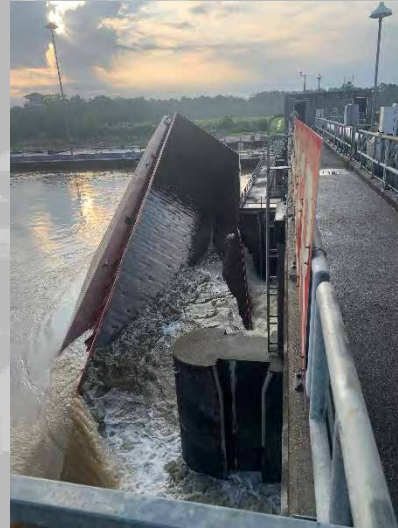
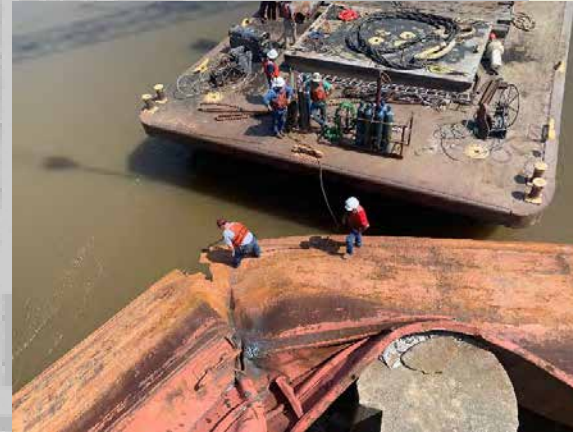
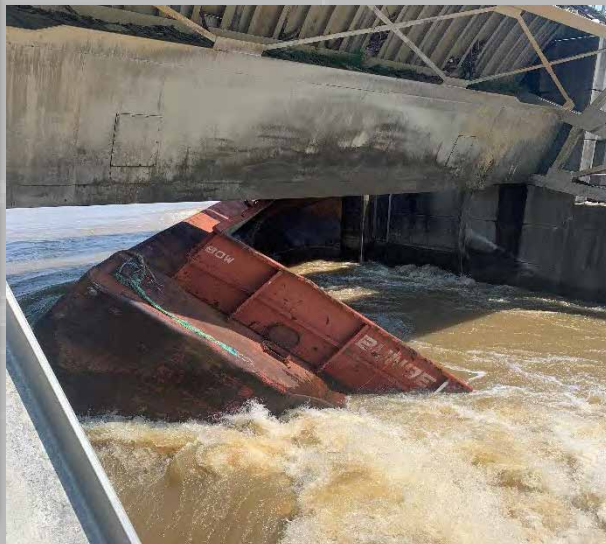
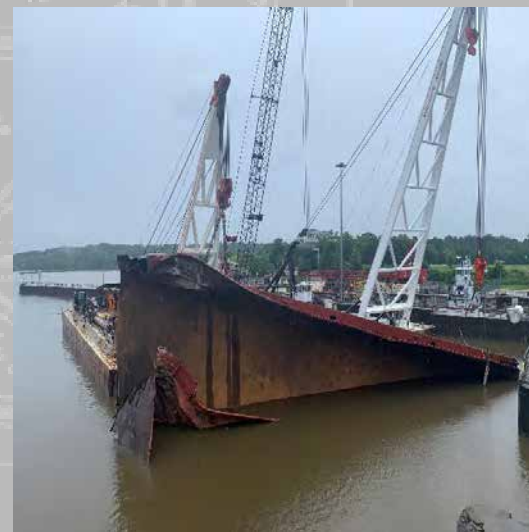
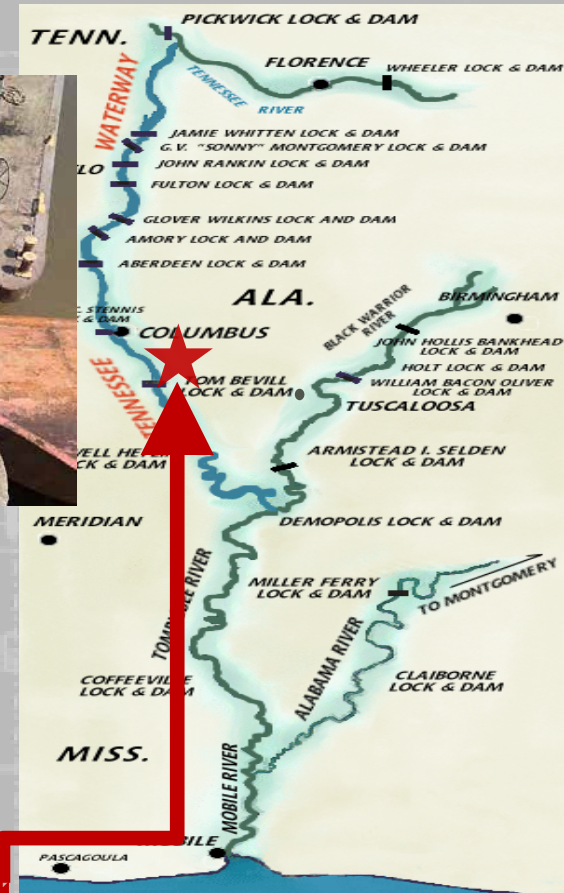
- 10 JUNE 2021
- Little to no damages to spillway gate
- Busted concrete piers upstream of gate
- Damaged handrail along abutment wall
- Loss of pool (~3' below normal pool)
- Regained pool within 12 hours

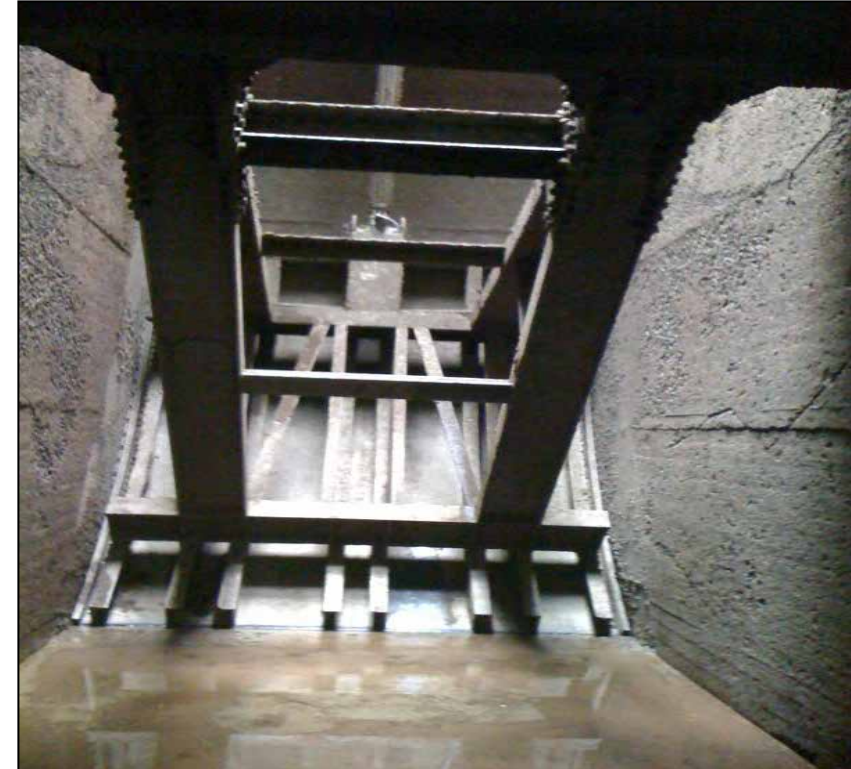
Lock Emptying / Filling Valve Repairs inspected and repairs made

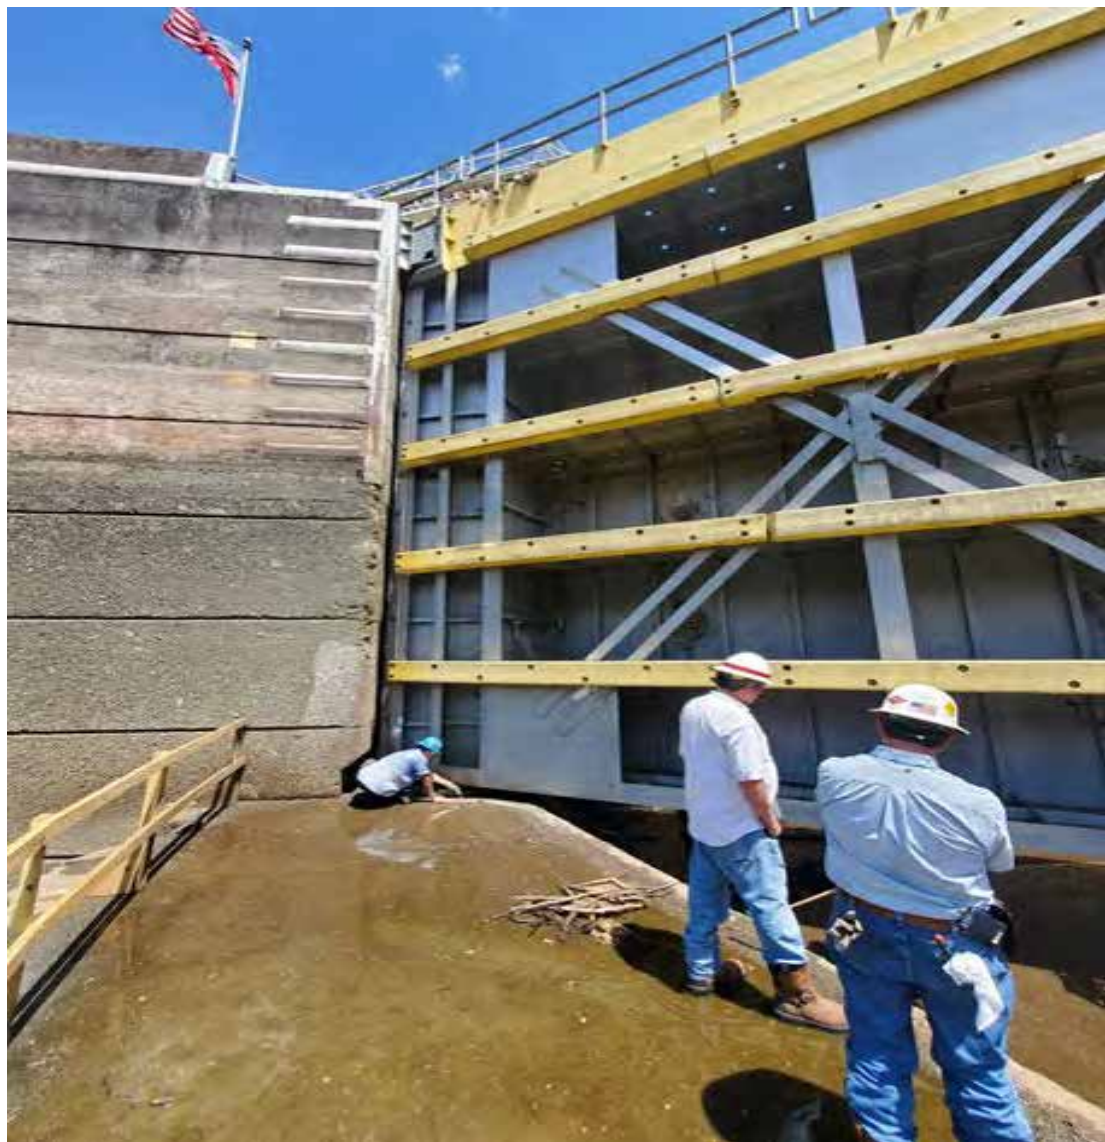
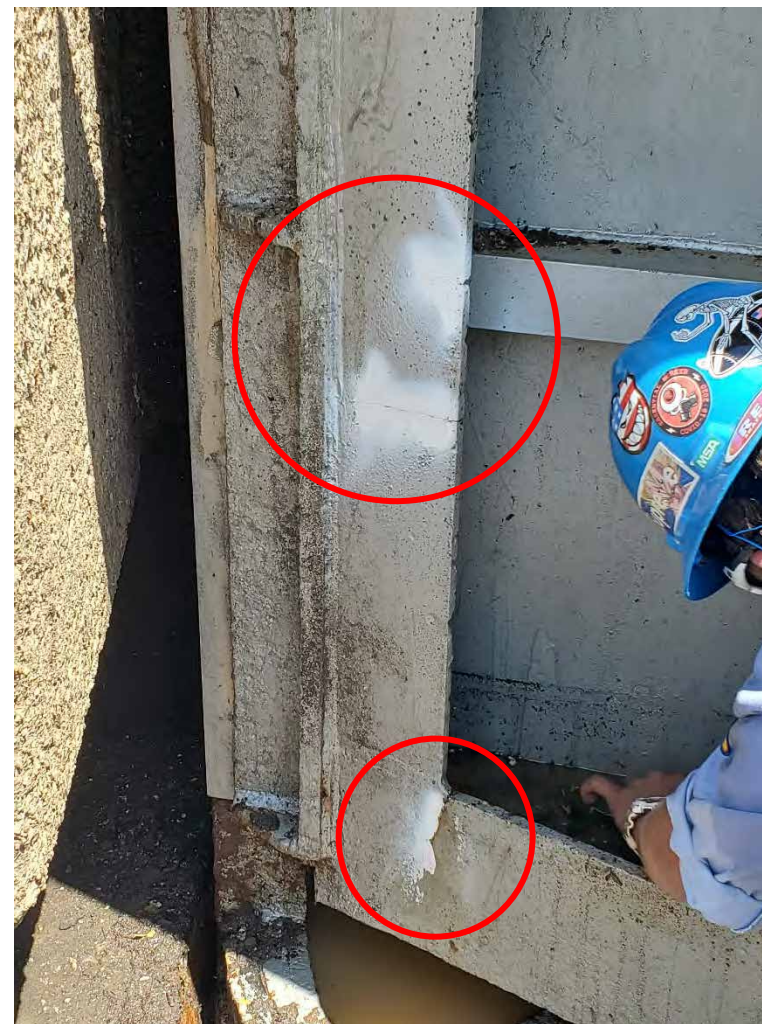
INSPECTION – CRACKS FOUND AND REPAIRED ON UPPER MITER GATE

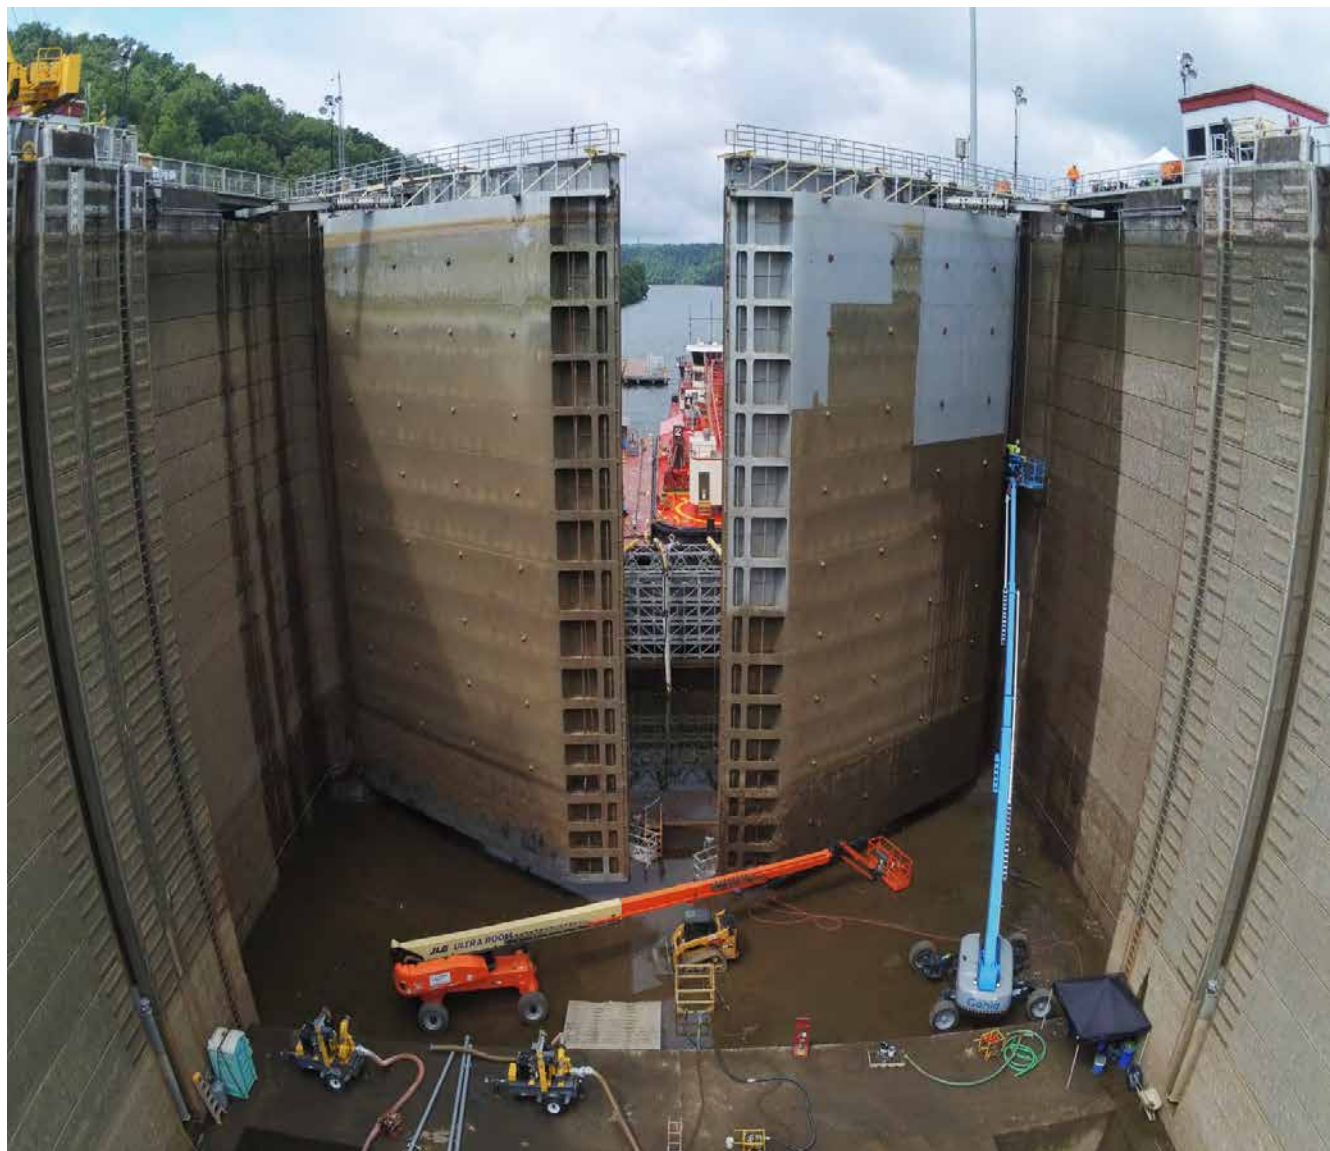
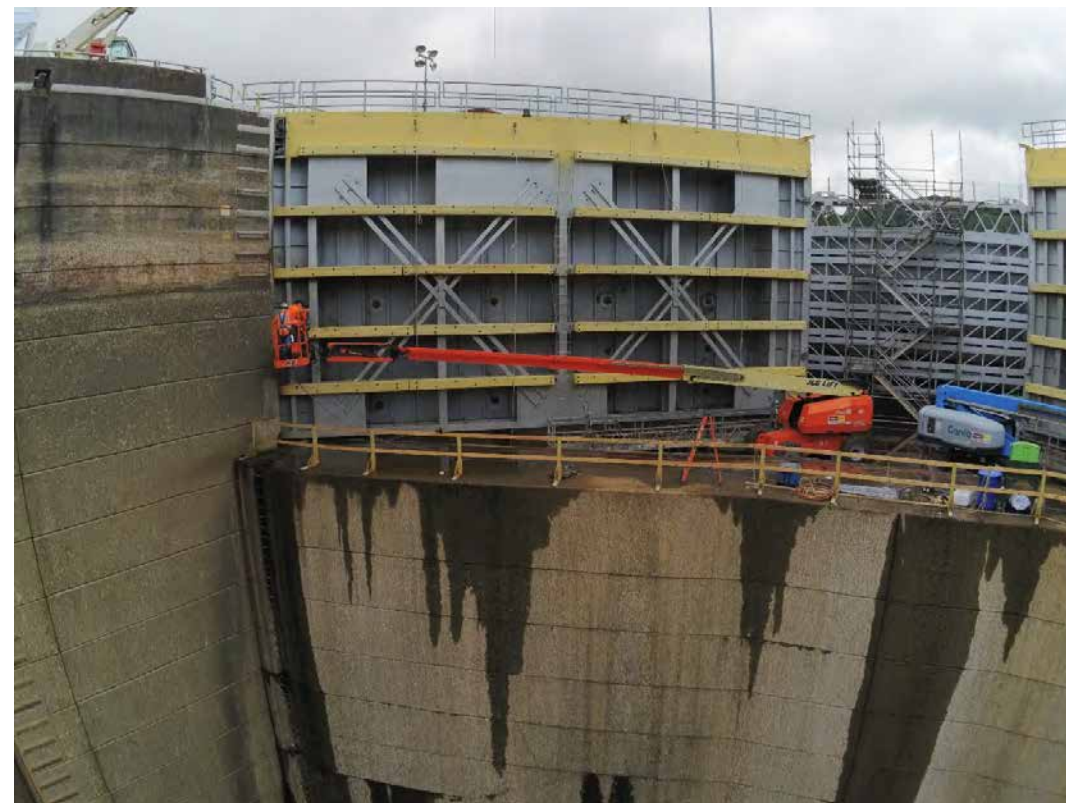
BANKHEAD LOCK – REPAIRS AND PAINT PREP
