BANKHEAD LOCK CLOSURE

NEW HOLT LOCK VALVES (4 TOTAL), WILL BE INSTALLED ONE AT A TIME **WITHOUT CLOSING THE LOCK.**

BLACK WARRIOR/TOMBIGBEE RIVER: COFFEEVILLE EMERGENCY LOCK CLOSURE – 14 APRIL 2021

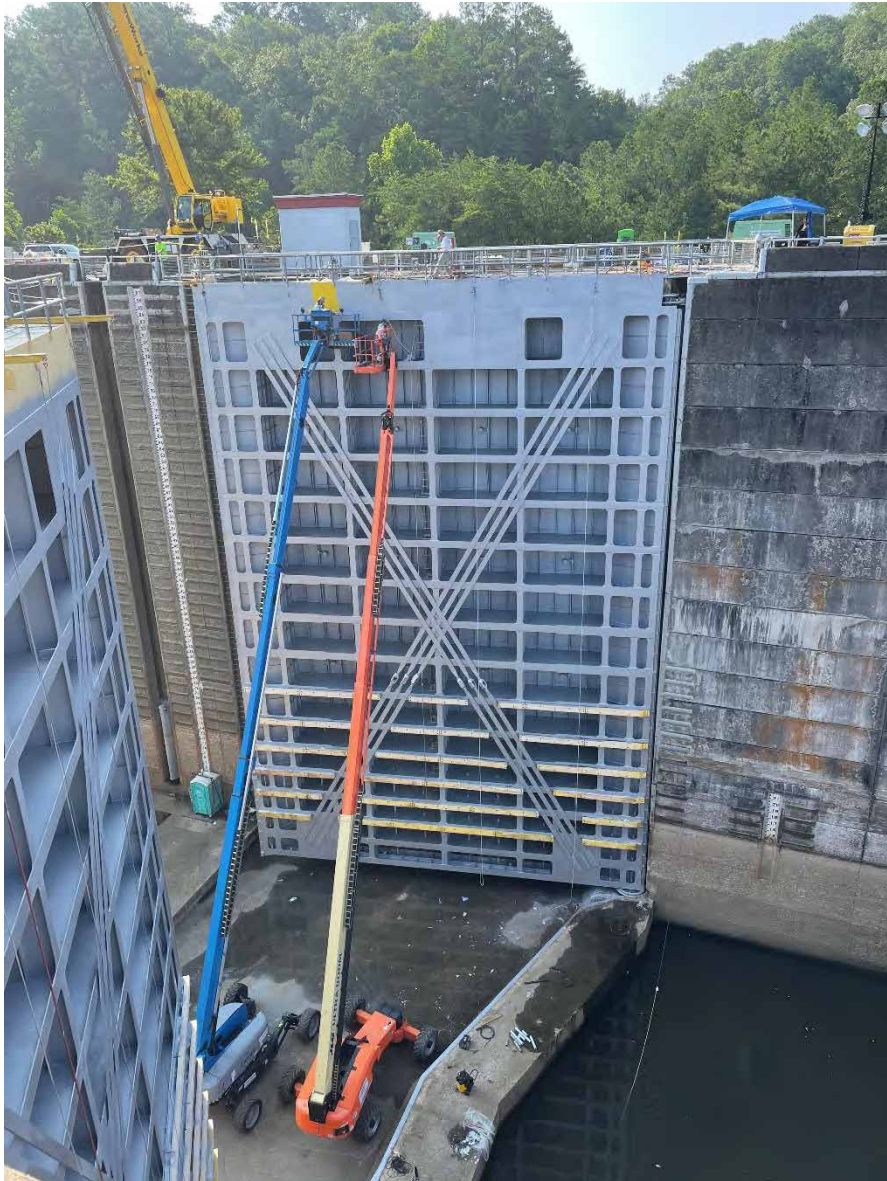
Painting lower gates

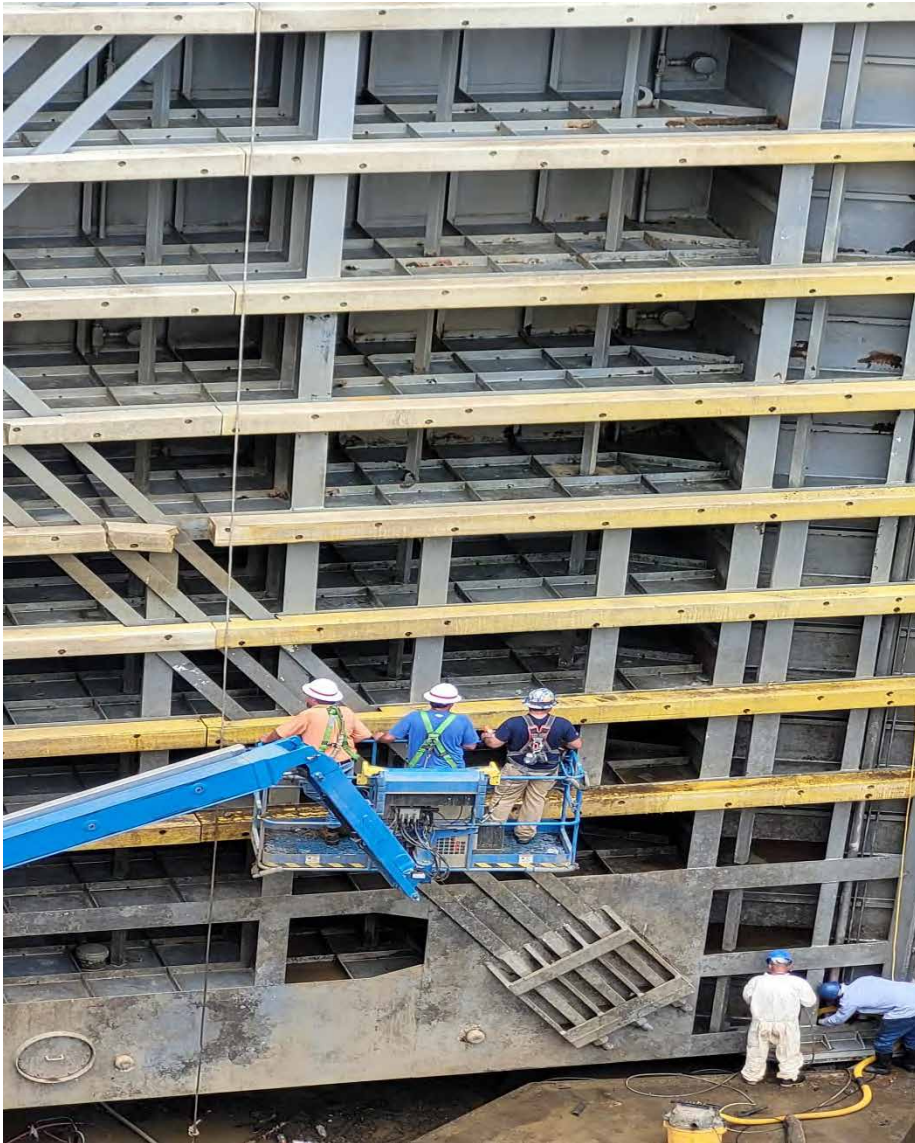
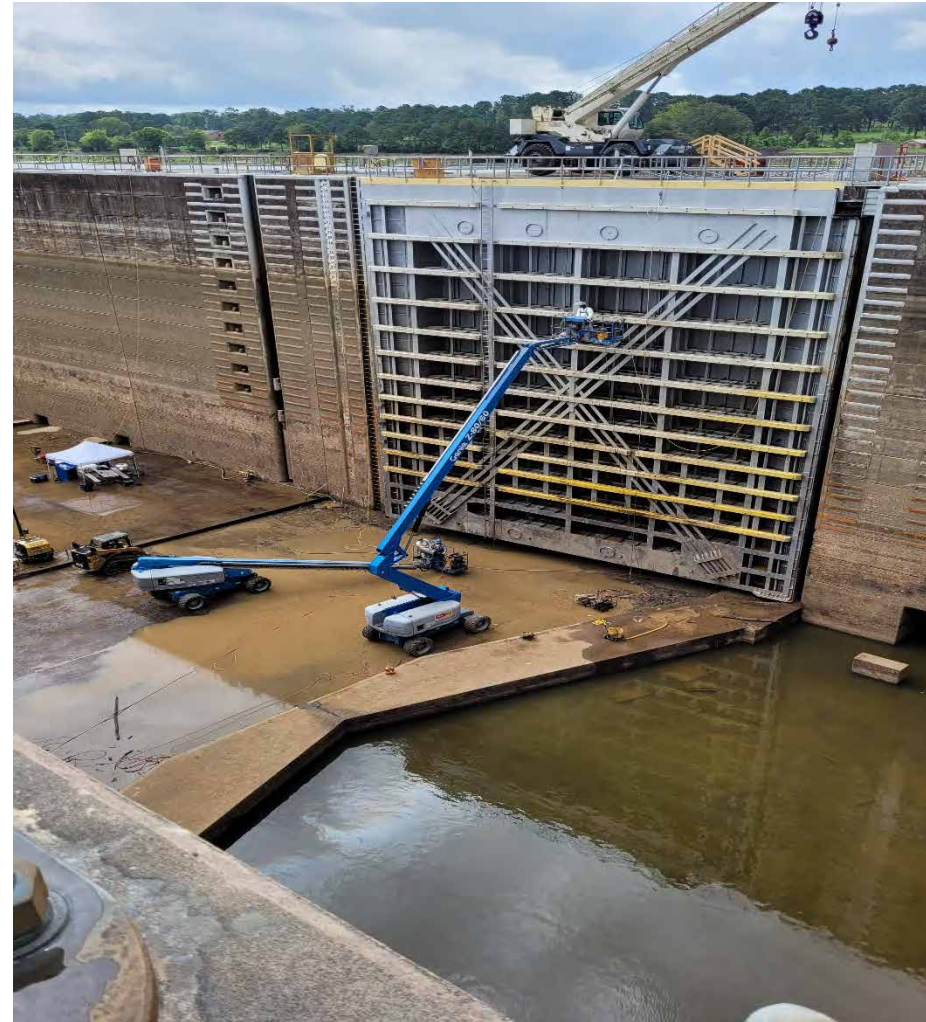
Oliver Lock dewatered, inspection & painting

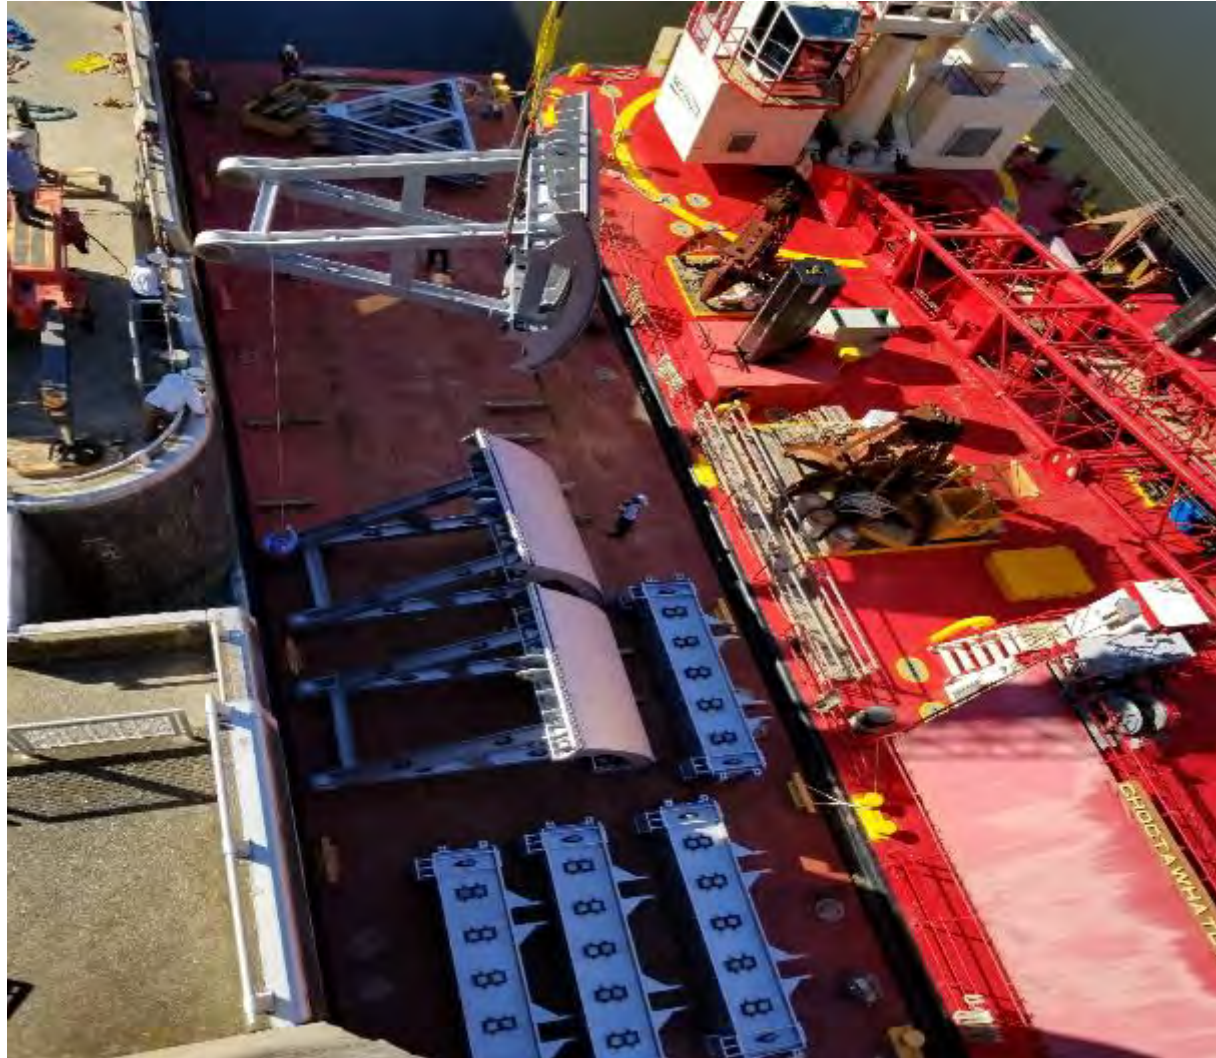
- UPDATE:
 - R&D Maintenance Services, O&M Contractor, in process of 1st of 4 replacements.
 - Anchor bolt and plates re-built and new girder beam installed.
 - Next, the new valve will be installed.

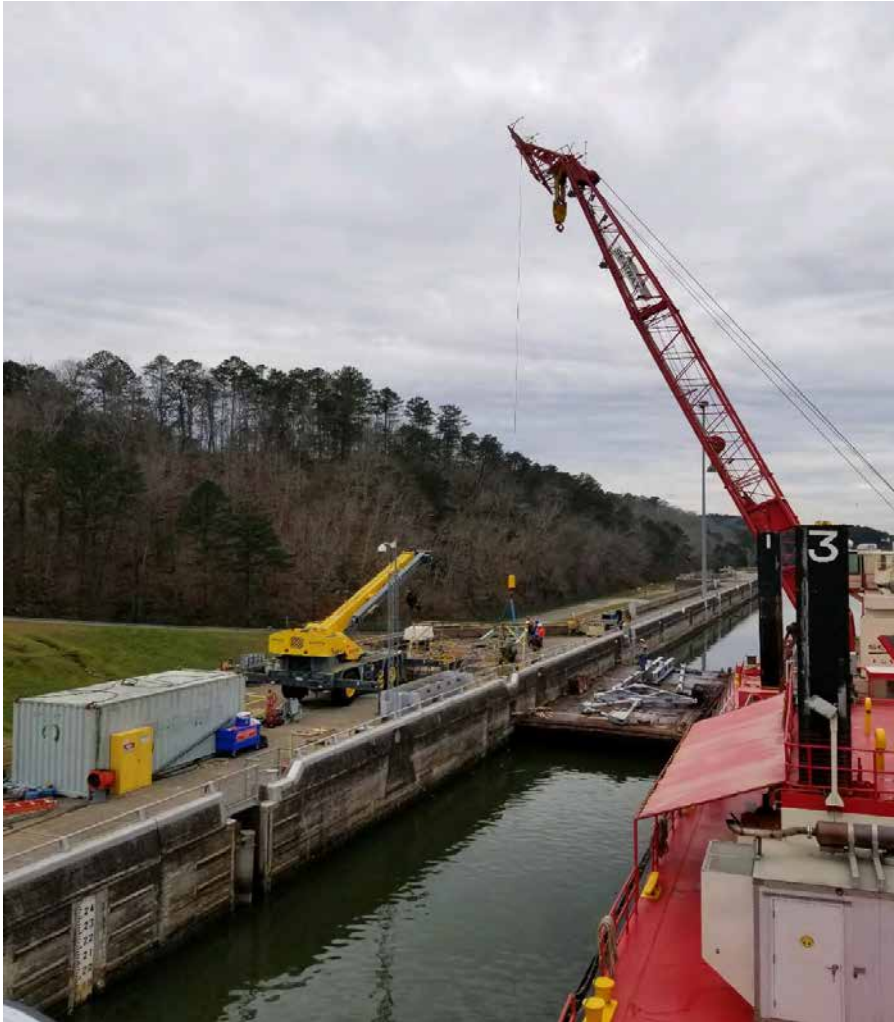
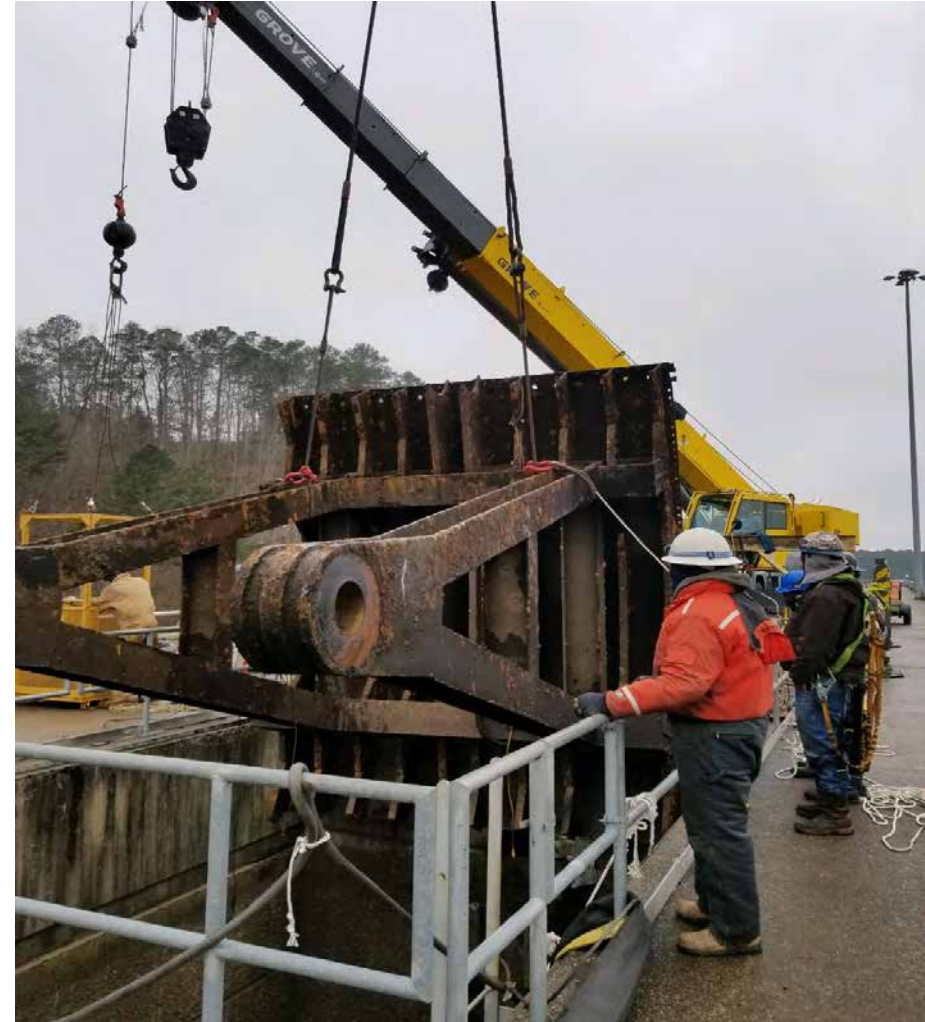
UPDATE : FLOATING PLANT/CRANE REMOVING OLD LOCK VALVE

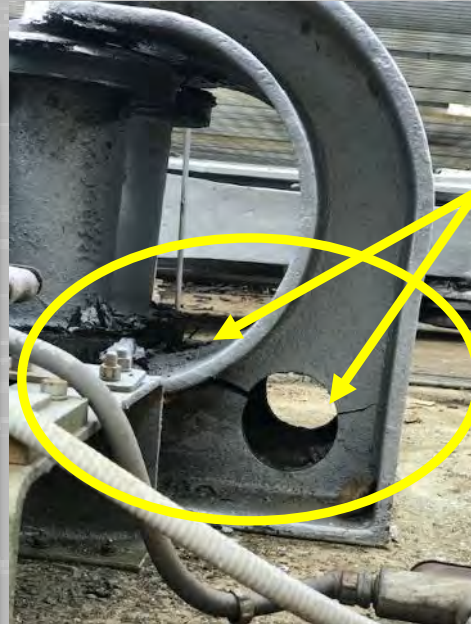
At approximately 1100 14 April 2021 the lock operators at Coffeeville Lock, Tombigbee River mile 116.6, noticed the lower river miter gate reaction roller base was cracked almost completely through. The reaction roller keeps the rack inline with the gate hydraulic cylinder and transfers the linear motion to the sector gear, which opens and closes the miter gate. Without the reaction roller the rack can fall out of alignment with the cylinder and sector gear, breaking the machinery linkage for the miter gate rendering it inoperable.

Crack running through the reaction roller assembly base

BWT Project contacted TTWW Project to secure a spare reaction roller assembly. It took some time, concrete removal, to remove the broken assembly and install the spare assembly to put the lock back in service.

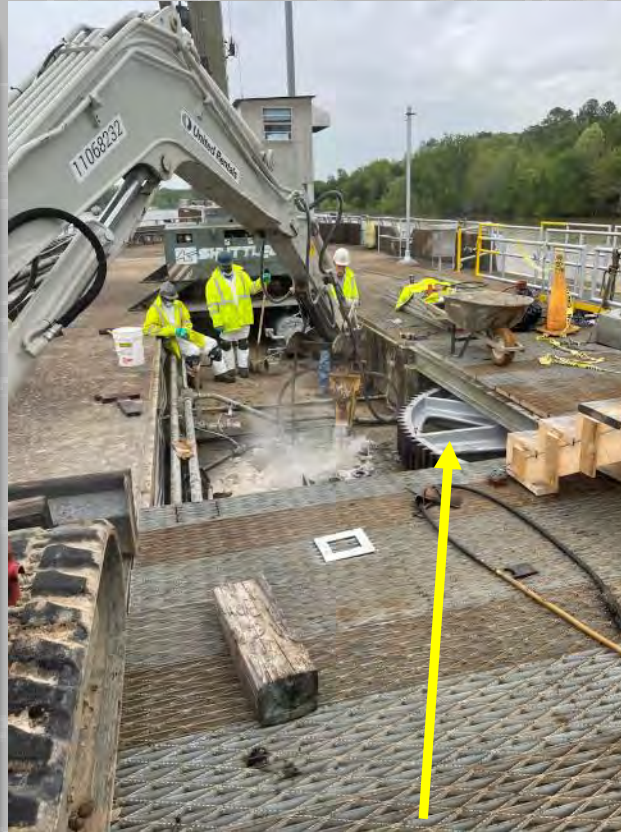
O&M contractor maintenance removed concrete around the embedded roller assembly base and the sector gear base.

Mechanical hammer chipper being used by O&M contractor maintenance crews to remove the second pour of concrete that encases the machinery foundations.

Sector Gear

The roller assembly is bolted to the sector gear base with 12 turned bolts. Once the bolted connection was exposed the old base was removed and the new reaction roller assembly bolted to the sector gear base. Then the rack and rollers were re-installed and connected to the hydraulic cylinder. Once the machinery was reconnected and tested the lock was returned to service. Repouring of the concrete occurred once traffic was cleared.

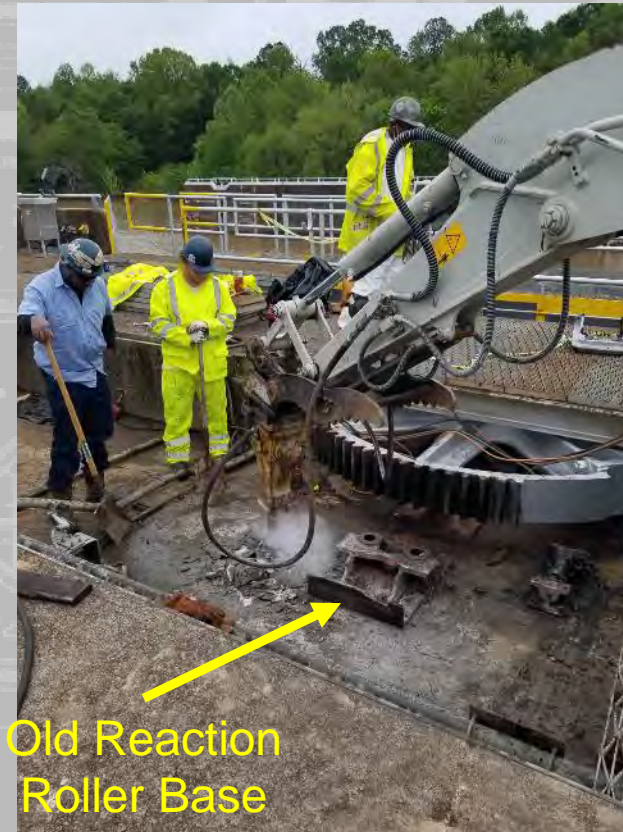
Old Reaction
Roller Base

Embedded
Sector Gear
Base

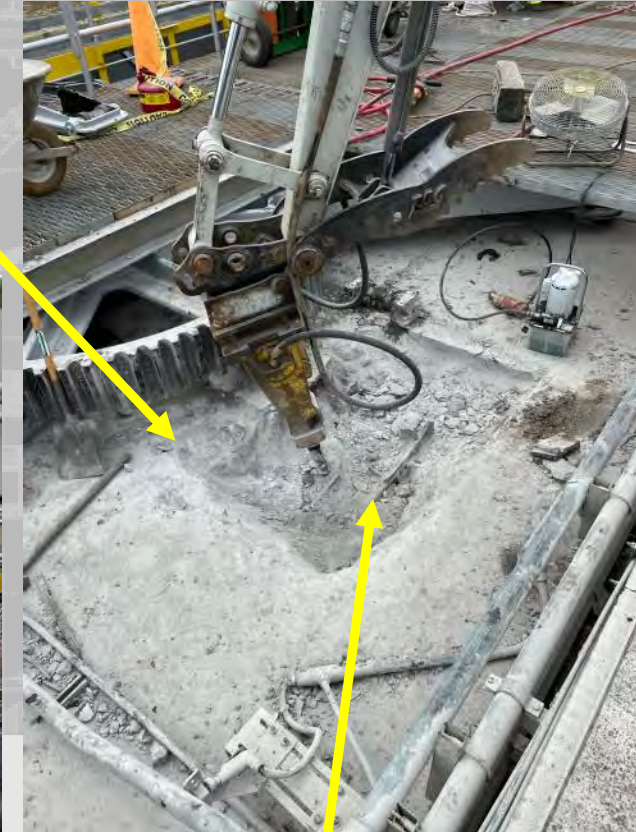
Embedded
piece of
Reaction
Roller Base

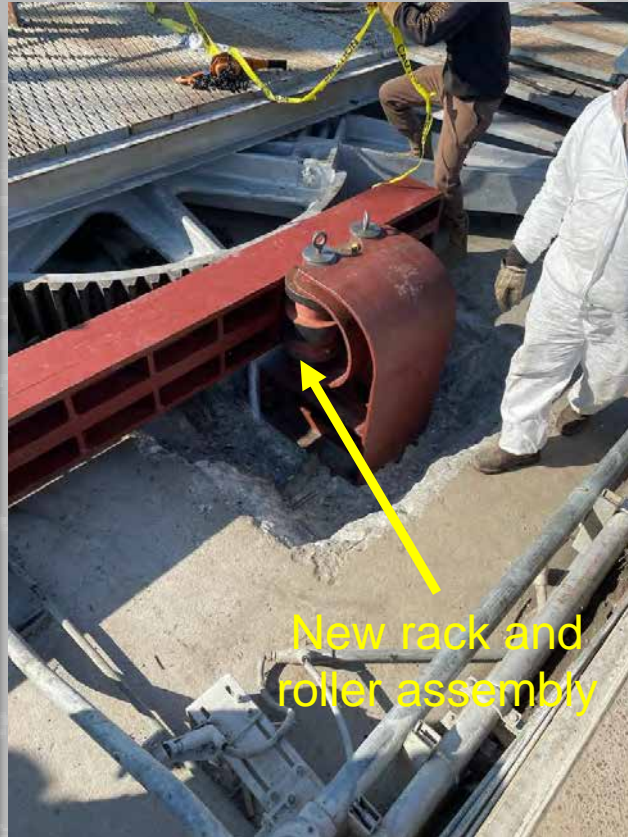
New rack and reaction roller assembly installed. O&M Maintenance crews ensuring proper alignment of components.

New rack and roller assembly

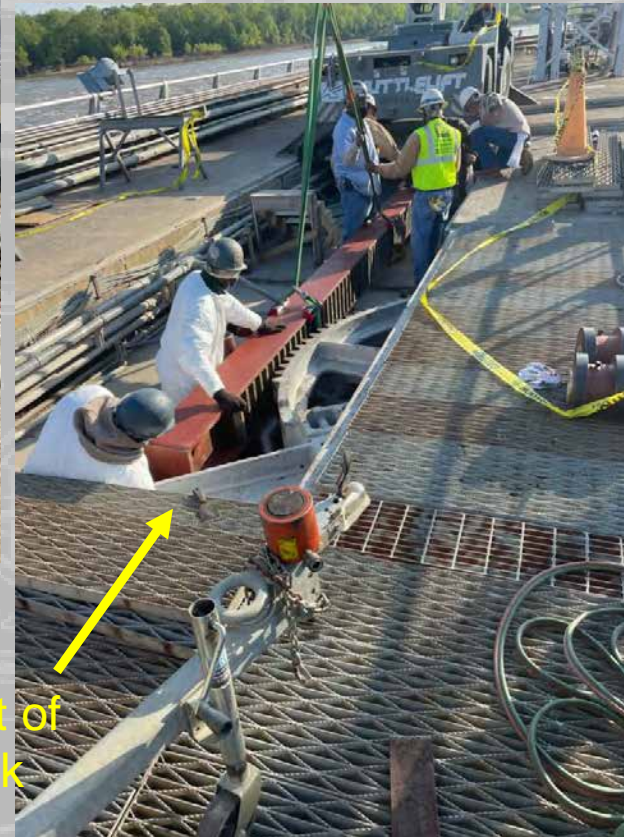
Once components aligned O&M contractor made final adjustments and testing of miter gate machinery.

Alignment of new rack
